MISCELLANEOUS PAPER S-77-26

# OBSERVATIONS OF PORTLAND CEMENT CONCRETE AND POROUS FRICTION COURSE PAVEMENT CONSTRUCTION

Soils and Pavements Laboratory  
U. S. Army Engineer Waterways Experiment Station  
P. O. Box 631, Vicksburg, Miss. 39180

December 1977

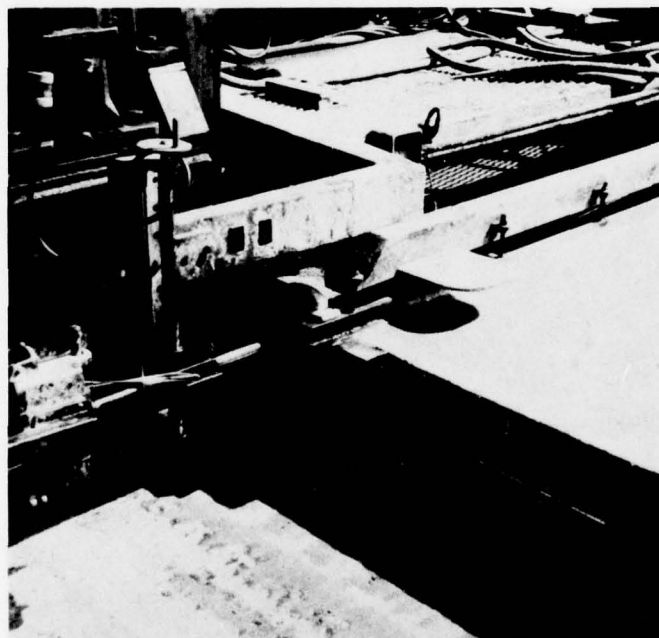
Figure 8. Edge of paving lane as formed by paver

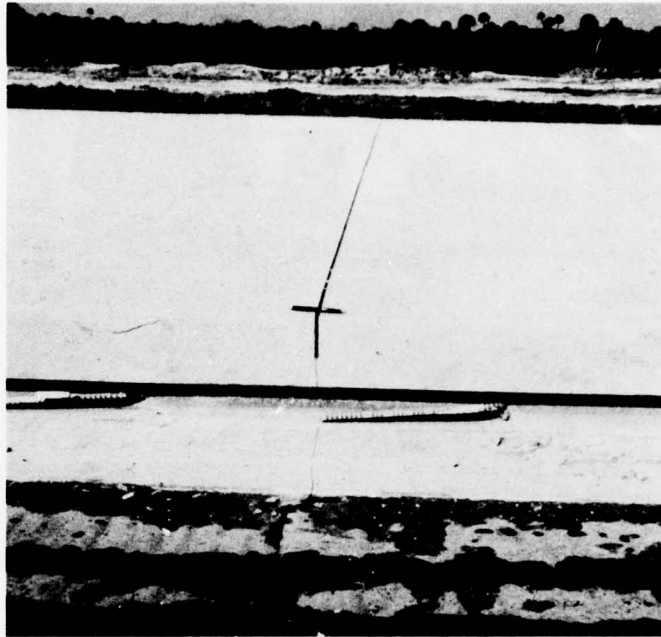
Figure 9. Keyed and tied longitudinal construction joint

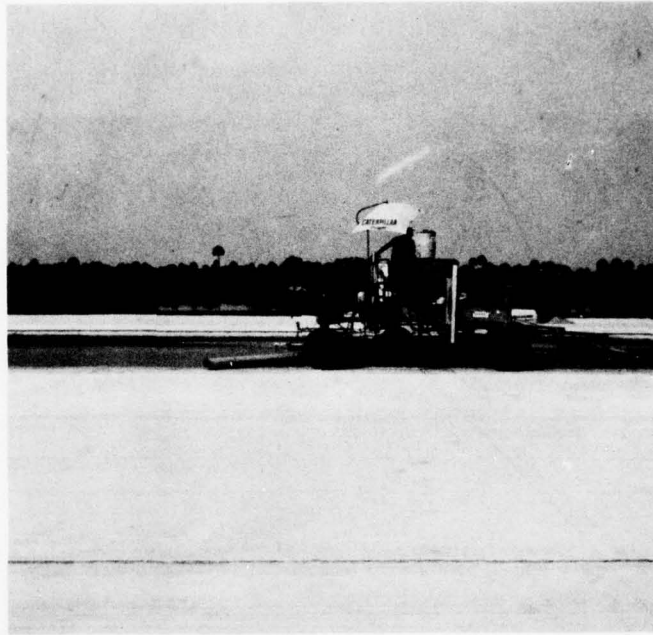
21. In the description of the initial visit it was noted that a brush was being used to texture the surface. This was now being used in the finishing operations. Tears and small depressions were being formed in the surface, and the brush was being used in conjunction with the tube float to move mortar around on the surface to fill these tears and depressions (Figures 13 and 14). The brush was moved back and forth several times over the surface, rather than only one time which is all that is necessary for texture application, and considerable mortar resulted as shown in Figure 14.

Figure 13. View showing pavement finishing  
(note both tube float and brush)

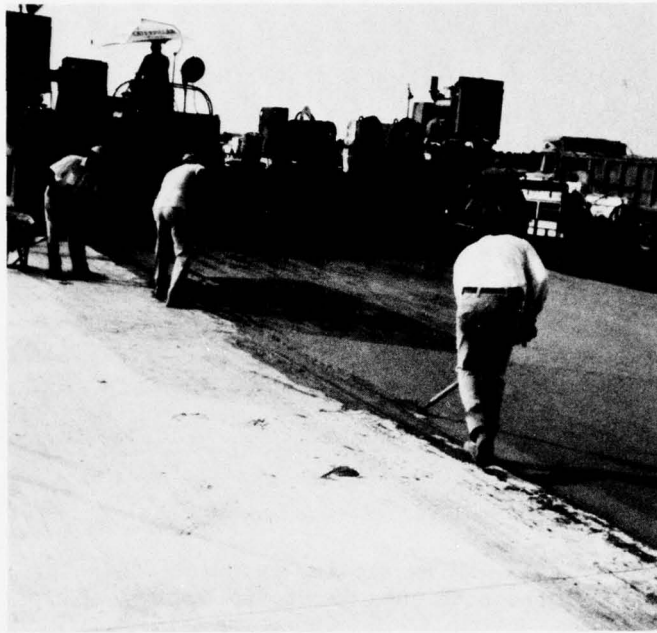
22. During this visit a paving lane was being placed adjacent to a previously placed lane resulting in only one free edge. Hand finishing along the free edge was limited to hand floating about 4 ft along the edge to draw mortar toward the edge, filling low spots, forming the edge with an edging tool, and removing excess mortar spilled along the edge. Along the fill-in edge a similar strip was hand floated and the mortar worked toward the edge. Its use here was also to fill in the low spots and to provide a smooth transition between the paving lanes (Figure 15). It appeared that the finishers were somewhat overzealous in their efforts to match the edges of the paving lanes and as a consequence were overworking the fill-in edge. This was confirmed by straightedge measurements which indicated that high spots were being built along the edge of the fill-in lanes.

Figure 15. Finishing operations between paving lanes

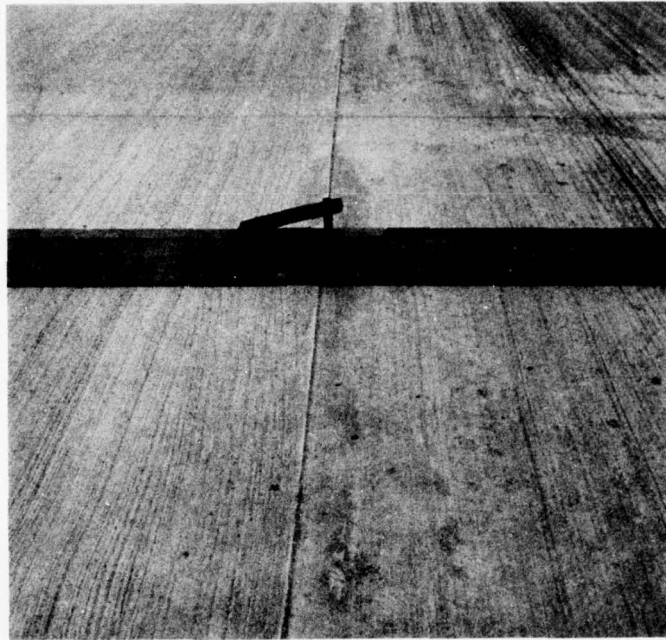
measuring tool because of the "slack" in the wheels and the flexibility of the straightedge, but it was a rather quick way to locate areas of large deviations. Considering the surface texture the straightedge was probably adequate. Rolling the straightedge across the runway revealed a very uniform surface. Of the portion of the pavement checked, which consisted of the six interior paving lanes near the center of the runway, no locations were found where the bottom of the straightedge actually touched the surface, indicating no locations where the surface deviated more than about 1/8-1/4 in. from the 16-ft straightedge. Rolling the straightedge along the runway revealed a number of locations where the bottom of the straightedge touched the surface. Upon more detailed examination only two or three locations were found where the 1/4-in. tolerance was exceeded. All of the locations where the straightedge touched were along longitudinal construction joints and in particular the joint west of the pavement center line. The joint east of the center line had only a few locations where the straightedge touched. The surface along this joint was indistinguishable from the paving lane interiors (Figure 16). However, along the joint west of the center line two distinct surface profiles were noted. Both were probably caused by the hand-finishing operations. These are shown in Figure 17.

Figure 16. Straightedge measurement across longitudinal construction joint

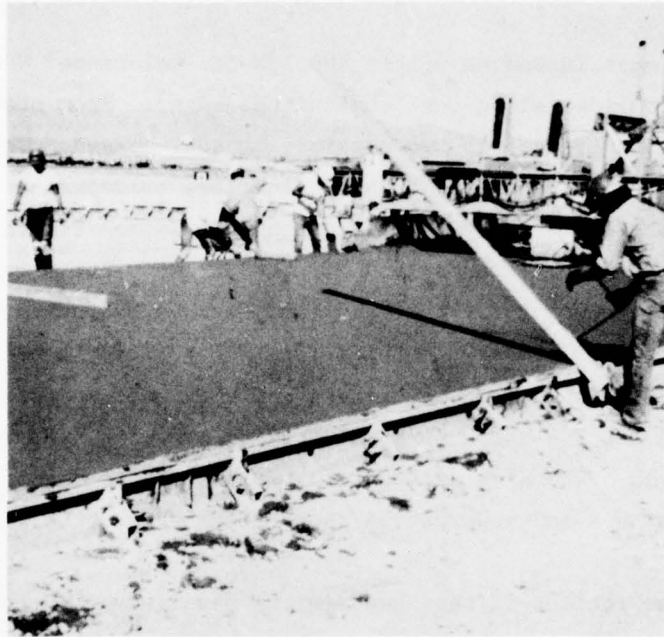
54. Checks of the surface with a 12-ft straightedge revealed that the longitudinal smoothness was very good with few apparent high or low areas. The transverse measurements consistently indicated a low area

Figure 29. Check of transverse smoothness

(although in most instances within the 1/4-in. tolerance) 4 or 5 ft from the edge (or a ridge along the longitudinal edge). From observations of the finishing operations two possible causes emerged. The apparent low area may have been caused by hand finishers building up the area adjacent to the forms or by the rollers on the Gamaco finisher, which did not completely move across and off the pavement but stopped along the edge. The tendency for the hand finishers to overbuild along the edges has also been observed on slip-form jobs. This is the area that is readily accessible to the finishers and they want to produce a square corner. As a result, there is a tendency to overwork and overbuild along the edges. The area adjacent to two transverse construction joints was checked and as expected these areas showed the poorest smoothness.

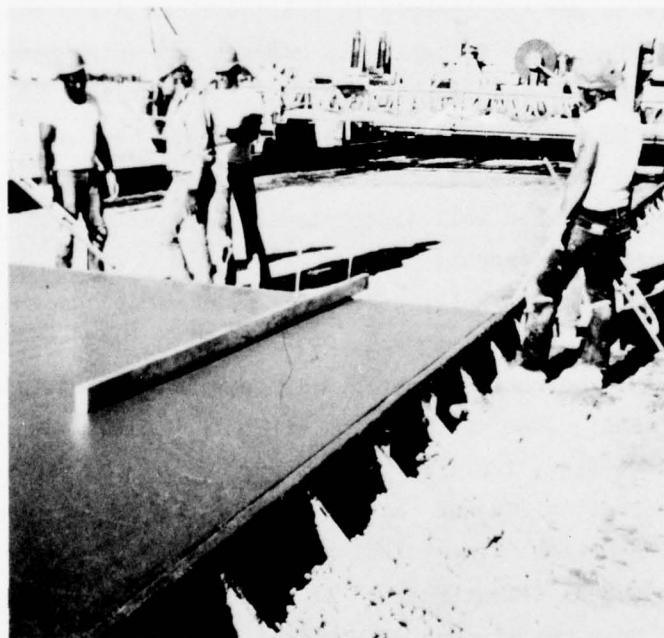
Figure 30. Check of smoothness near header

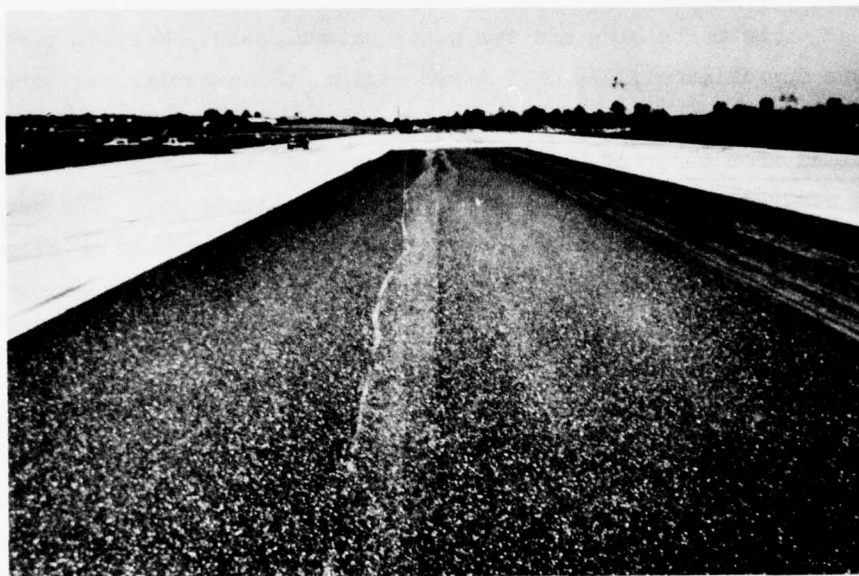
74. At cross taxiways, a 1/2-in. notch was cut into the pavement so that the PFC would butt into a vertical face. This requirement seemed to be redundant, resulting in extra work. Past experience indicates that satisfactory performance can be expected if the PFC edge is left free. Initial, after-construction raveling will occur until the free edge raveling to an angle of repose, and then raveling will stabilize. MRD personnel felt that the screed operator on the laydown machine overcompensated for the thickness of pavement, resulting in a variation in thickness. It was suggested that future PFC jobs require that a full-time laydown inspector be supplied either by the government or by the

Figure 34. General view of PFC pavement

contractor to ensure that proper screed height is maintained. This job also emphasizes that the minimum thickness allowed be not less than the maximum aggregate size.

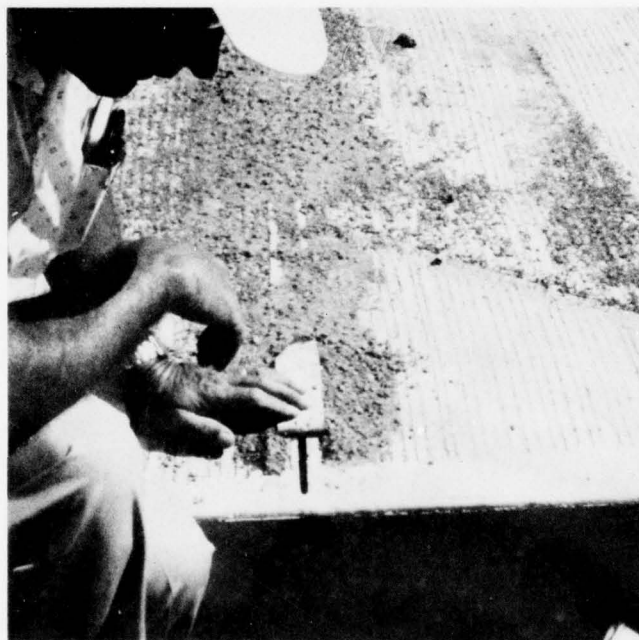
81. No joint construction problems were noted or mentioned by CE personnel. The alignment of longitudinal joints and dowels in these joints appeared to be adequate. Transverse contraction joints were dry sawed with abrasive blades. The groove was 1/4 in. wide and 4-3/4 in. deep. No uncontrolled cracking had been experienced. After sawing, the grooves were blown out with compressed air, flushed with water, blown dry with compressed air, sealed with masking tape, and covered with wet sand (Figure 44). Details of the special joint between the old and new PCC pavement were as recommended in TM 5-824-3.<sup>8</sup> No particular problems were observed or mentioned by CE personnel.

Figure 44. Sawed groove for transverse contraction joint
